SODA SPRINGS AIRPORT (ALLEN H. TIGERT)

This report describes how your pavement maintenance management program was developed. This program was developed as part of the Network Pavement Management Program project sponsored by the Idaho Transportation Department, Division of Aeronautics. The information and data contained in this report ensures you are in compliance with the requirements of Federal Aviation Administration (FAA) Grant Assurance Number 11 which states that any airport requesting federal funds for pavement improvement projects must have implemented a pavement maintenance management program (PMMP).

Using the branch, section and sample unit divisions established, a visual condition survey was conducted at Soda Springs Airport (Allen H. Tigert) on November 05, 2006. During the inspection pavement defects were identified and measured in accordance with the methodology outlined in FAA AC:150/5380-6 and ASTM D5430. Our inspection ensures your airport complies with the “detailed inspection” requirement of FAA’s PMMP guidelines. After collection, the data were entered into the Micro PAVER software for analysis. These data are reproduced in the Re-Inspection Report attached in

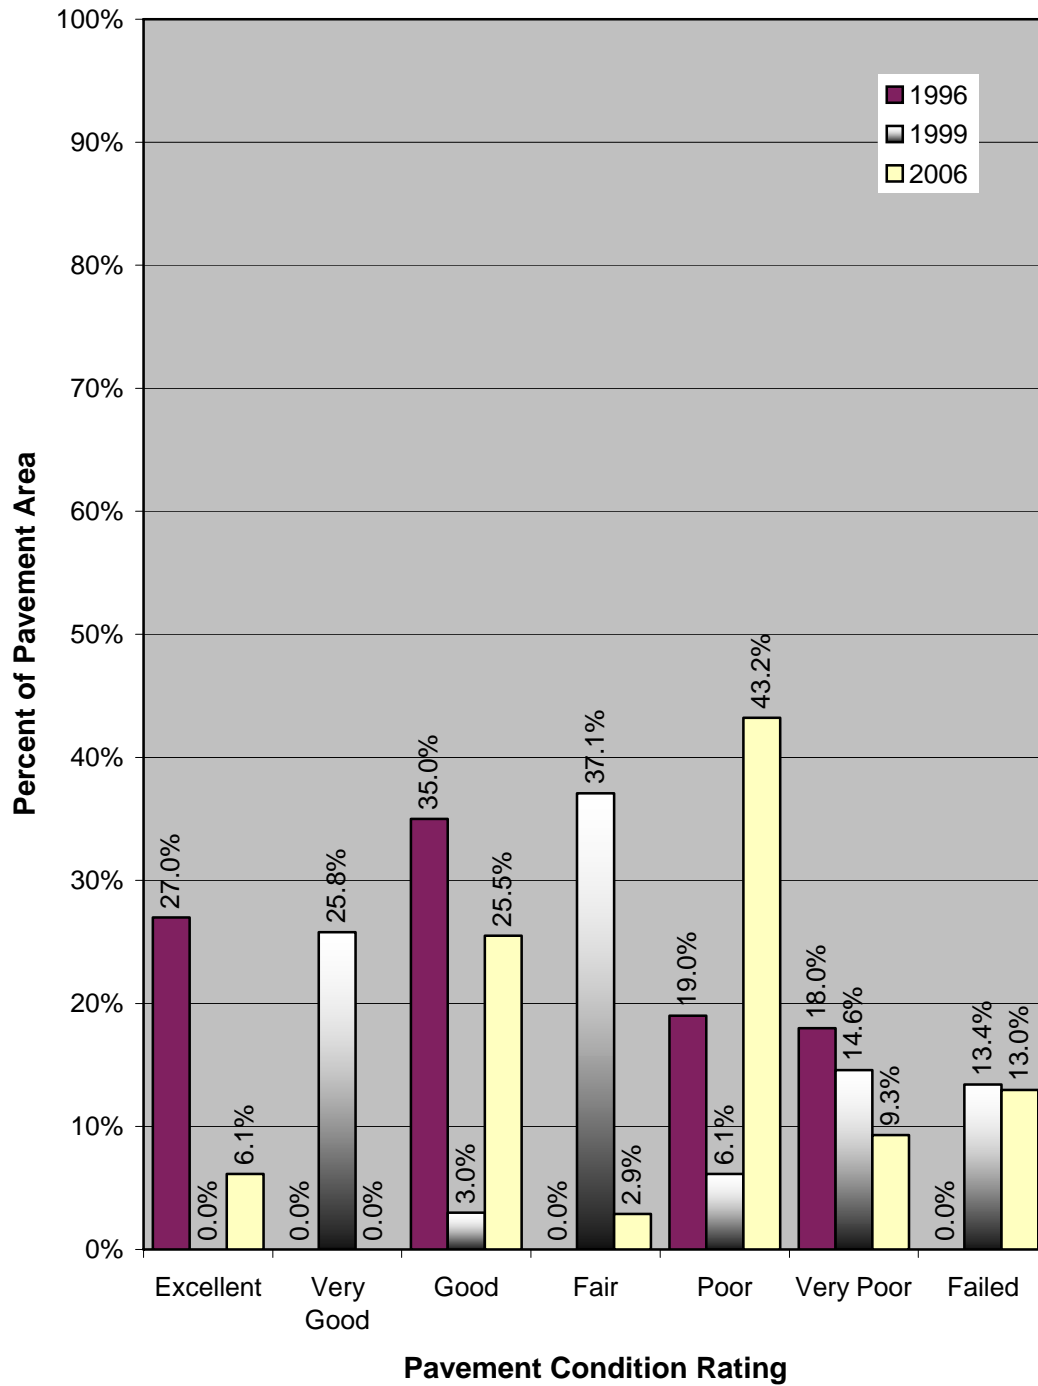
**Figure SS-4. Distribution of Pavement Condition
Soda Springs Airport (Allen H. Tigert)**

Section PCIs at the airport range from a low of 1 (a PCR of “Failed”) to a high of 100 (a PCR of “Excellent”). The area-weighted average PCI for all airport pavements is 41, corresponding to an overall PCR of “Fair”. Figure SS-4 shows how much pavement area is associated with each Pavement Condition Rating category and also shows pavement condition distribution from the inspections conducted in 1996 and 1999. A graphical representation of the projected PCRs presented in Table SS-2 is shown in Figure SS-5.
